Refit projects

Doc. 05

Title	Refit of hull, deck and mast of Trintella 38 - BN971-Kopanoar
Category	General
Content	The report on the hull refit, the replacement of the teak deck with a Flexiteek synthetic deck, the repair of mast corrosion, and the installation of a dry toilet carried out by the shipyard and the owners, Marike and Leon van Meer, between 2022 and 2024.

Refit Trintella 38, Kopanoar

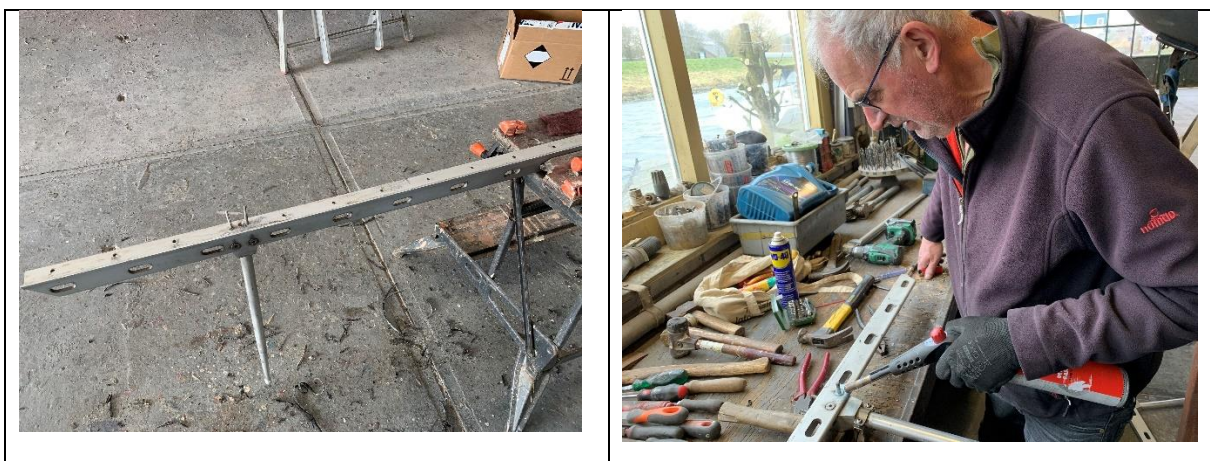
Disassembling and taking apart the toe rail with stanchions was a big job

The stanchion sockets with their stanchions were taken home and delivered to a metal workshop. Even there, they were unable to separate the stanchion sockets and stanchions; they were completely stuck. Two threaded rods originally protruded from the bottom of the stanchion sockets, most of which have now broken off. These will be drilled out and new

threads will be tapped into them. To get everything reassembled in the right place later, Leon will have to drill out some holes on the toe rail where the new threaded rod will need to pass through. The stanchion sockets will then be numbered with a corresponding number on the toe rail so that everything can be smoothly reassembled later.

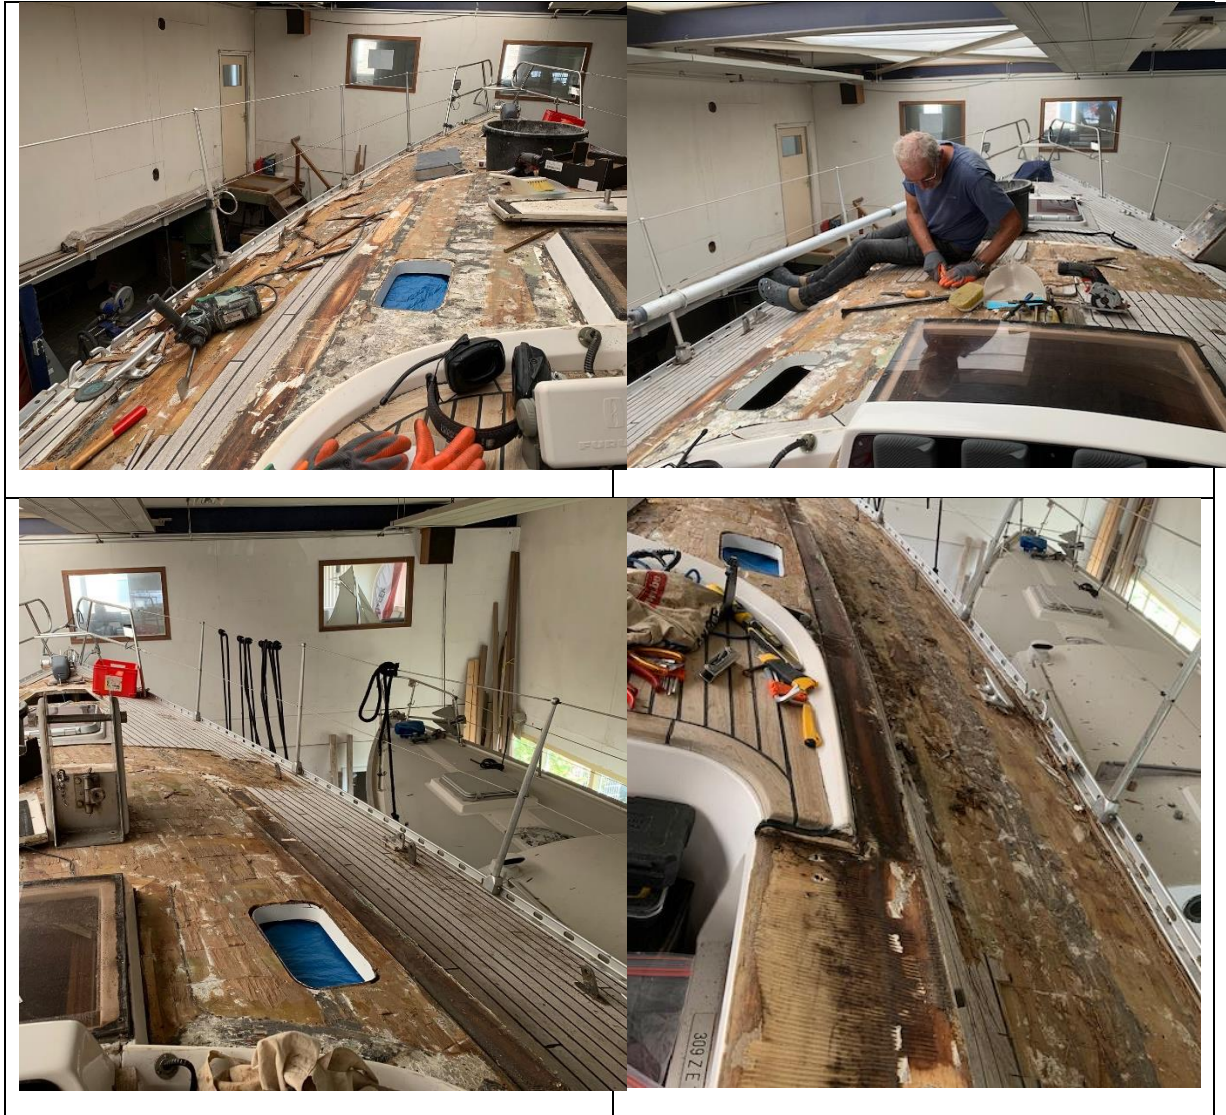
And then came the teak removal with a hammer and chisel, and thankfully, an electric chisel combined with a circular saw. Because our teak deck wasn't screwed but glued, and was partially embedded in the polyester, it certainly didn't come off easily. At least not in whole pieces, but in splintered pieces.

The removal of the teak deck

The underlying GRP got quite damaged in the process and required extensive filling. The shipyard applied two new layers of GRP to the entire deck, superstructure, and aft cabin. During these weeks of work, we also decided to remove our underwater toilet and replaced it with a dry toilet (Ecosave). A wastewater tank wasn't an option; besides the cost, we anticipated traffic jams at the "poo slurper" on weekends and holidays. The two seacocks on the underwater toilet were removed, and the holes in the hull sealed. We will use two other existing seacocks for toilet flushing and urine disposal. While we're at it, we decided to replace all the brass ball seacocks with plastic ones.

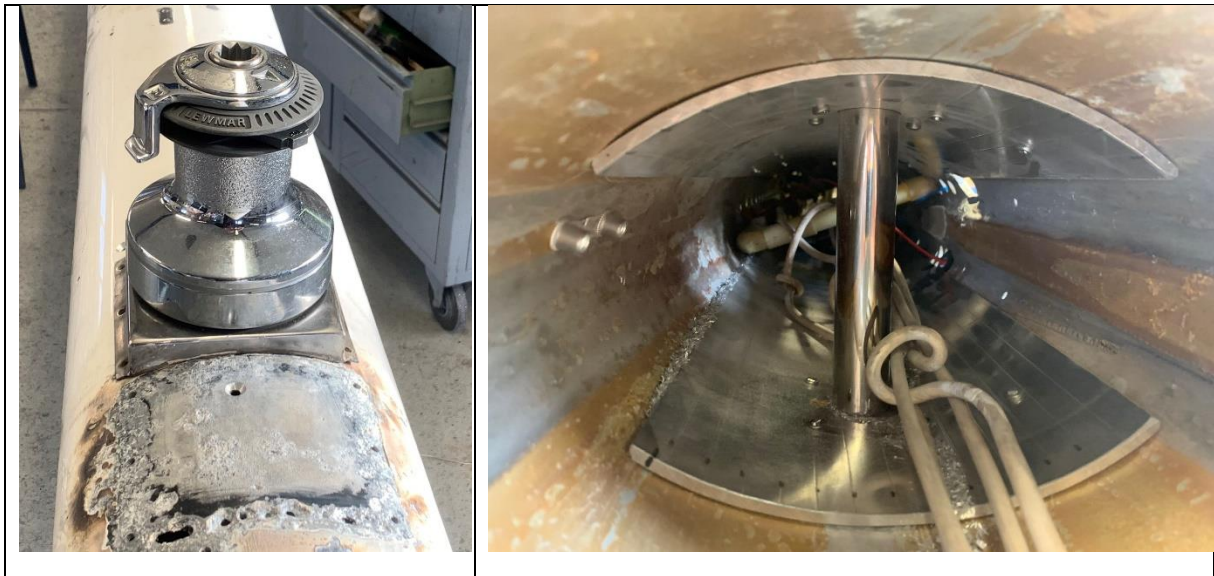
The mast is at Neut Mast next to Offerhaus because we were also going to replace the rigging. Whilst removing the old rigging, we had a critical look at our mast. Previous owners had painted the mast, boom, boom vang, and spreaders white. Well, we looked at each other; there's quite a bit of damage. Should we sand the mast and repaint it? Ronald Offerhaus offered to spray-paint the mast and boom, but that would mean removing all the fittings from them as well. We decided to go for it, and we were very happy with the outcome. In the mast shed, we removed all the fittings from the mast, including a few bolts that are failing again. We bend a sturdy screwdriver on them. When removing the winches from the mast, we were shocked by the large corrosion holes appearing underneath. In one spot, the corrosion was so severe that Neut recommended grinding it open. The Neut crew got to work, grinding away the damaged area and making a mold for the aluminium plates that will go on the inside of the mast. These plates were placed on the inside and are partly riveted and partly screwed. When replacing the winches and cleats, the plates will be pulled even further against the mast.

Corrosion under mast winch and repair with insert plates

Fortunately, we now have a sturdy mast again. Now it was up to us to remove paint from the mast, boom, boom vang, and spreaders. All in all, this job took us a good week. Offerhaus will spray-paint the mast, boom, boom vang, and spreaders. Then we started reassembling the mast and boom. We have replaced the cleats on the mast, the three-color masthead light, the steam and deck light, the radar reflector, the pulleys in the mast, and the power and VHF cables.

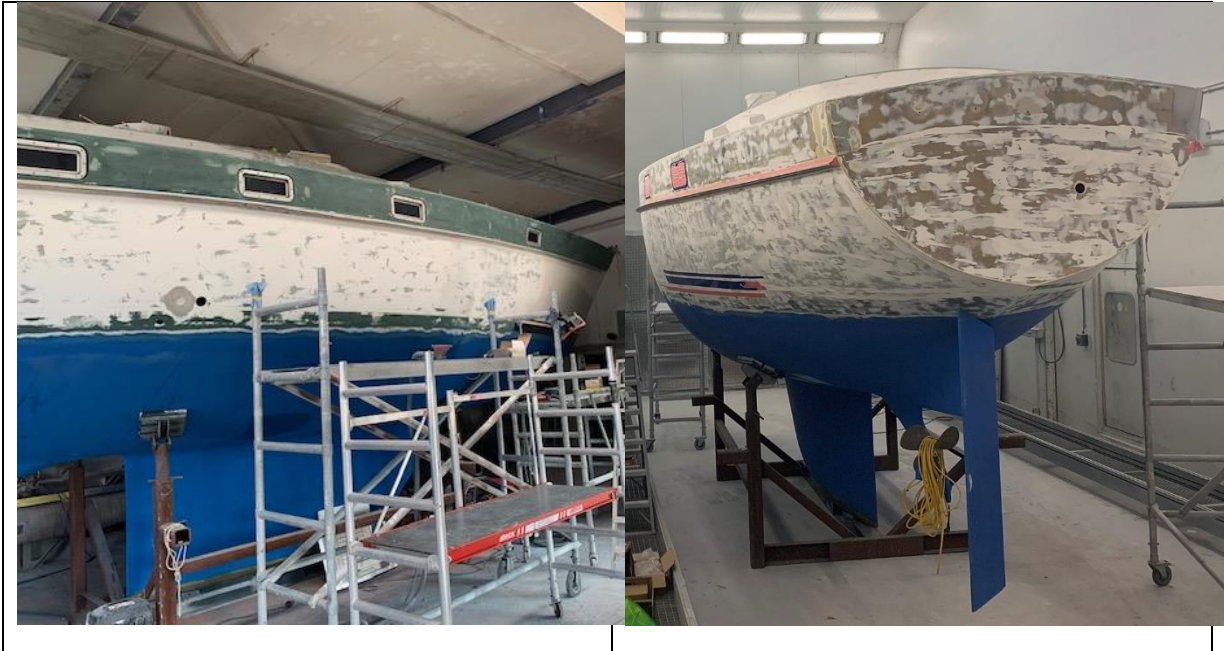
originally dark green. While sanding the hull, a large, repaired damage came to light, one that we were unaware of. There was delamination, so a hole was cut in the hull and rebuilt with glass mats. It turned out that the hull had extensive cracking, and it needed to be sanded back a very long way. This jeopardized the schedule for completion in the summer of 2023. As we didn't want to rush things at the last minute, we decided to choose a different holiday destination.

Filling and sanding

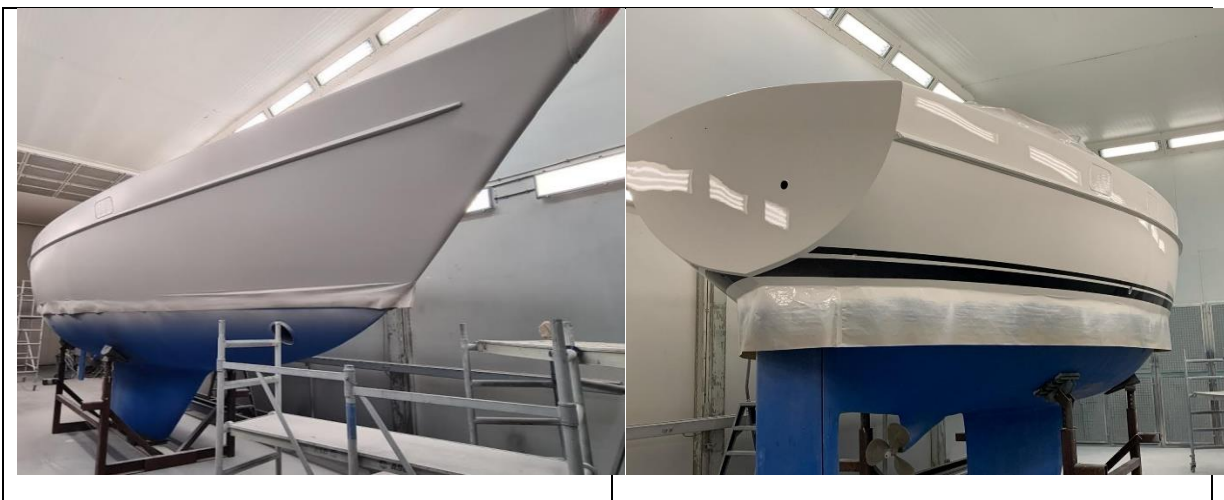
The paintwork was finished mid-January. We were getting a glimpse of our boat's new look. The superstructure has been painted a different shade of white than the hull. Anti-slip paint will be applied to the superstructure, cockpit coamings, and aft cabin instead of Flexiteek. The large blue stripe above the rubbing strake and around the windows was not restored. The waterline, which was too low, has been raised about 12 cm with a double, very dark blue stripe.

In the spray booth

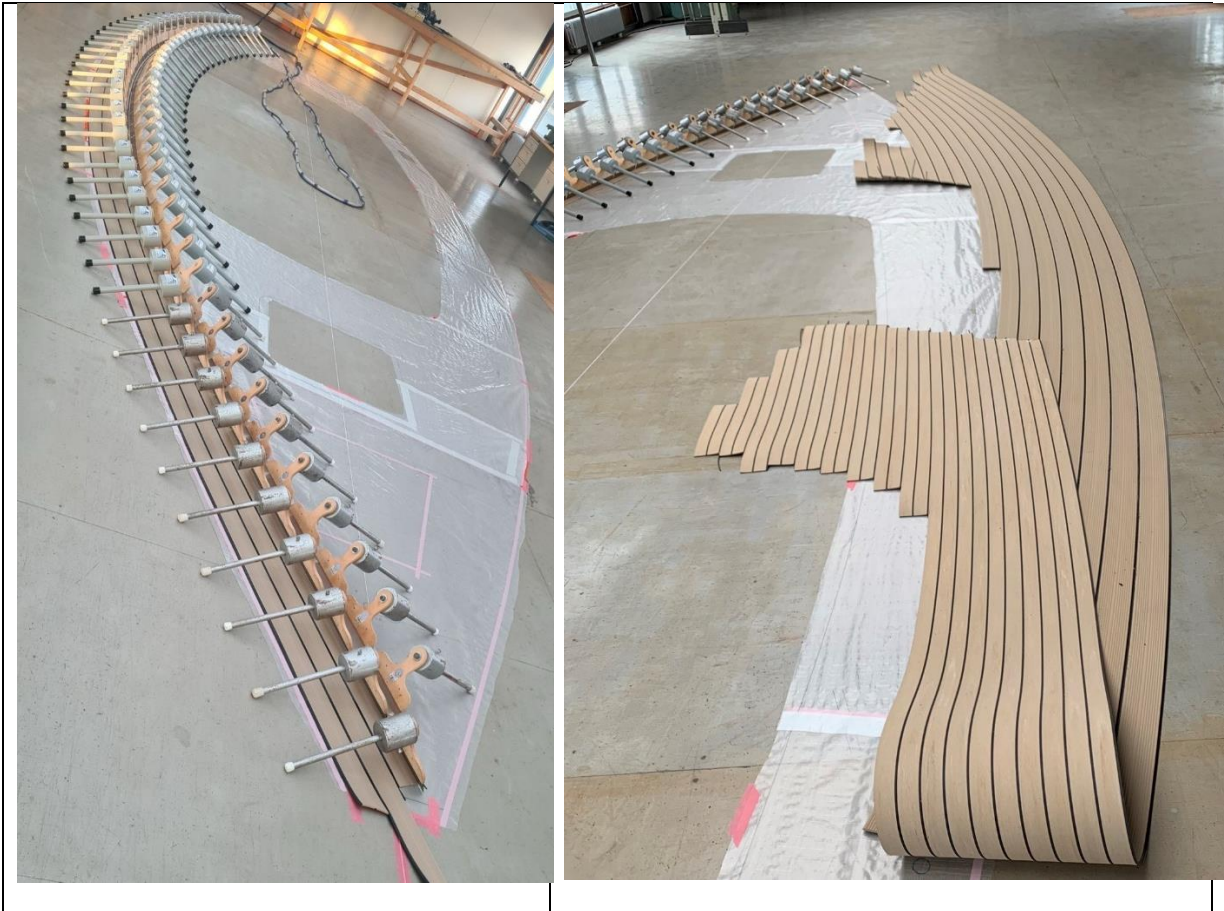
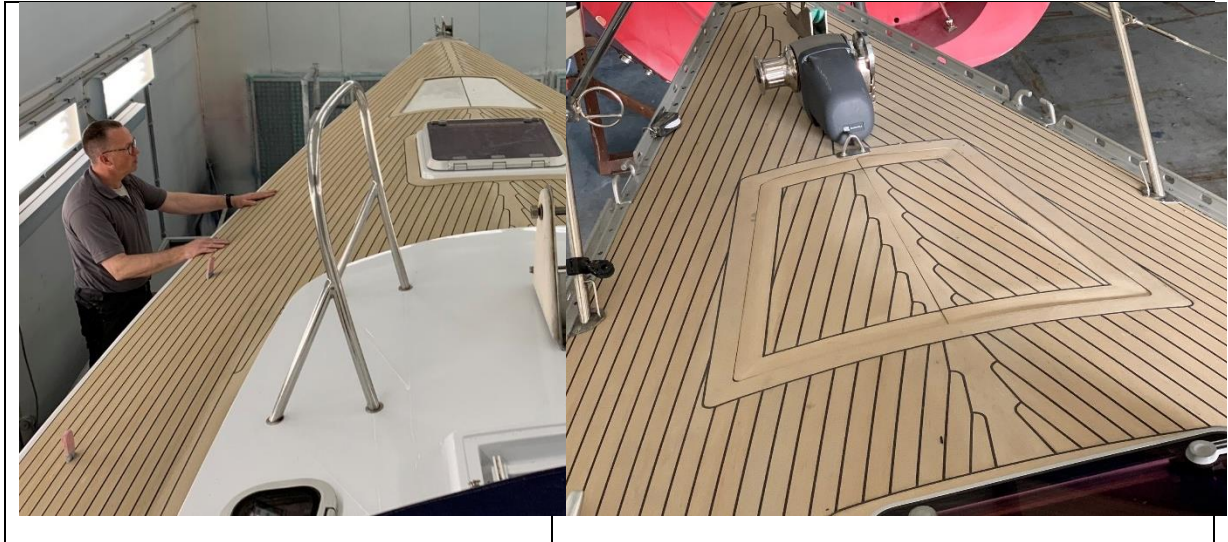
Fitting the Flexiteek

Then we had a little break. The shipyard started laying the Flexiteek. First, a mold was made of the deck. The Flexiteek strips were placed on it, fitted, cut, and welded together. Then the fiddly work began. Think of the fishing section on the foredeck and the timbers around the superstructure, the escape hatch on the foredeck, and the lids of the anchor locker and lockers. Once everything was welded together, the deck was rolled up and fitted onto the boat. When everything was correct, the Flexiteek was glued to the deck and vacuum-sealed. This entire process takes about 3-4 weeks. Fortunately, we regularly received photos from the shipyard showing the progress of our new deck.
