| | <h1>Refit projects</h1> <h2>Doc. 06</h2> |
| <b>Subject</b> | Refit of Trintella 38 - BN982-Van Holland |
| <b>Content</b> | The report of a special project, shortening and modifying the keel + refit of underwater ship and hull + installing new oil bath propeller shaft bearings. |

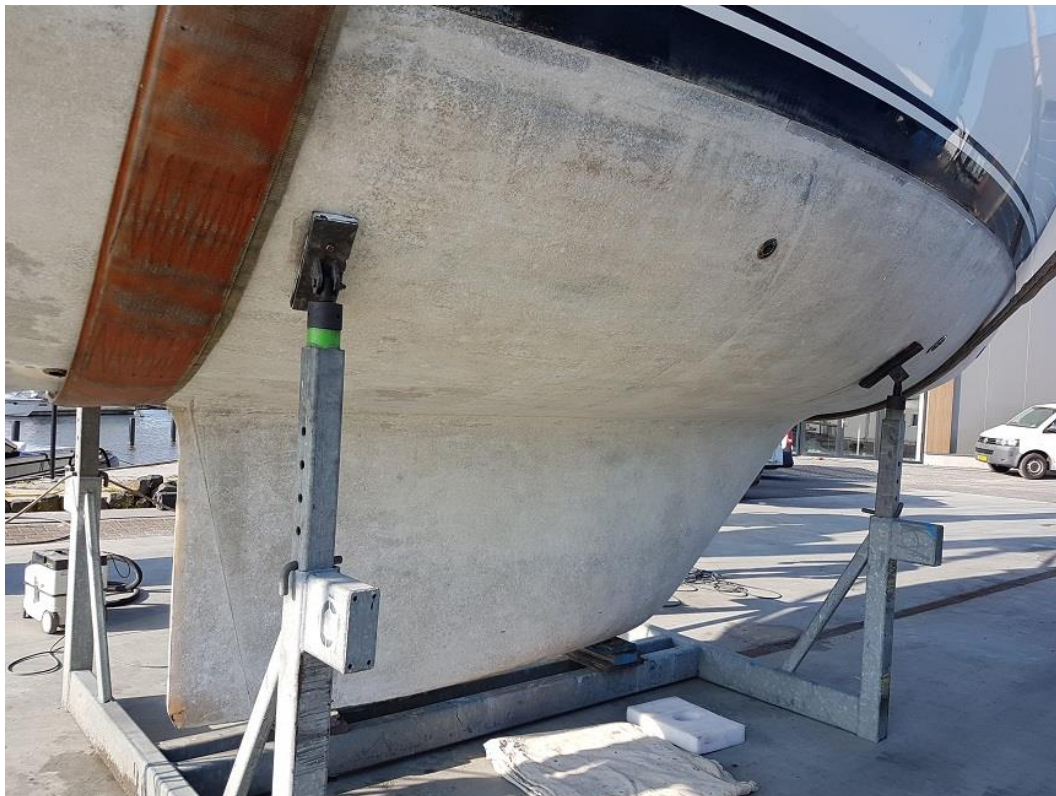
*The hull stripped and ready for keel modification*

We decided to reduce the boat's draft by 5 cm, sacrificing around 120 kg of keel weight. After discussing the plan on-site with Van de Stadt and Dick Koopmans, we concluded it wouldn't negatively affect the sailing characteristics or stability of the boat.

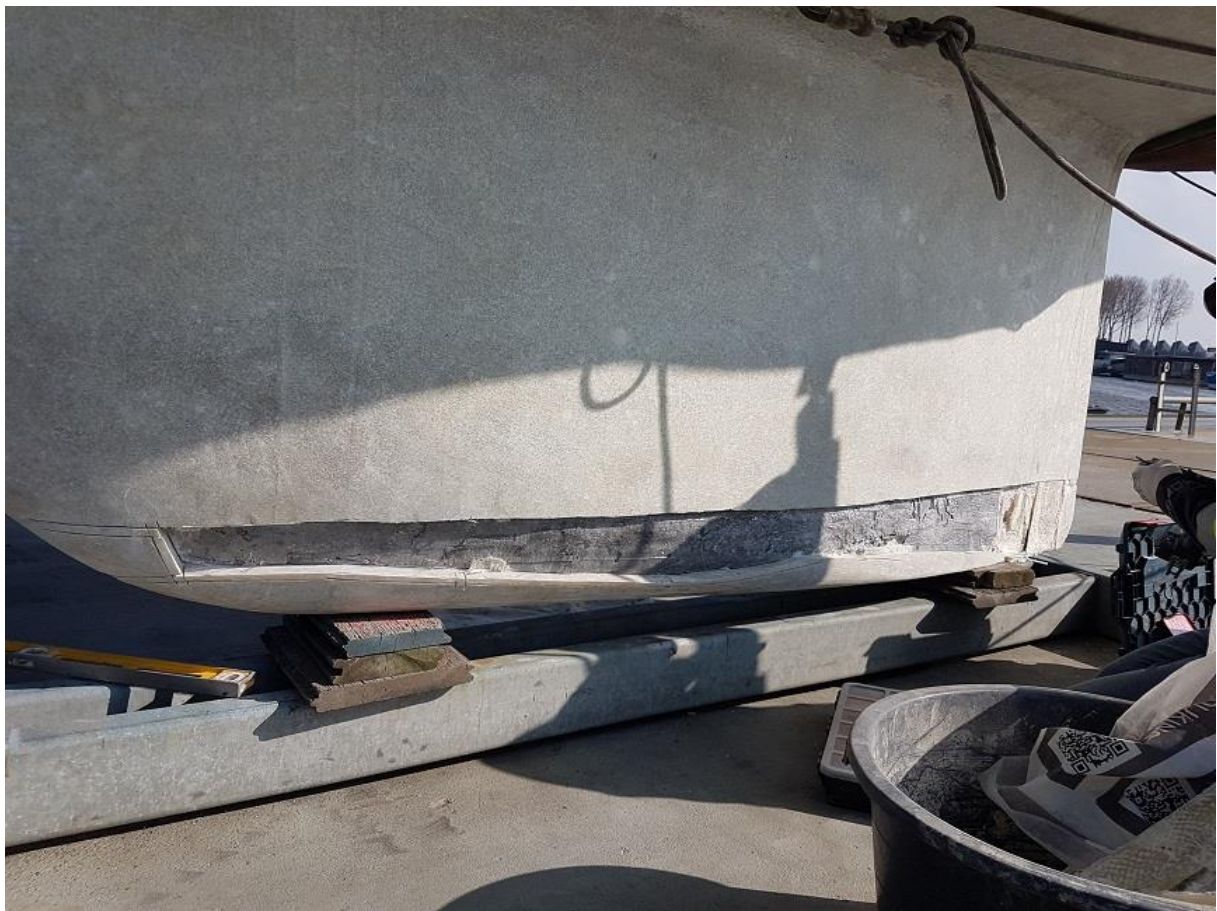
*Removing the polyester 12 cm above the future cut line in the lead*

We first carefully cut into the polyester hull to locate the lead beneath. The aft section of the keel turned out to be about 25 cm of solid polyester, which we first trimmed down to the desired height. After measuring, we made a full cut around the hull down to the lead, 12 cm above the future cut line. Once the cuts were made, the shaped polyester piece came off with just a few hits with a hammer. The polyester turned out to be up to 35 mm thick — very strong. We secured the sidewalls with screws and threaded rods to prevent the lead keel from shifting downward when hoisted.

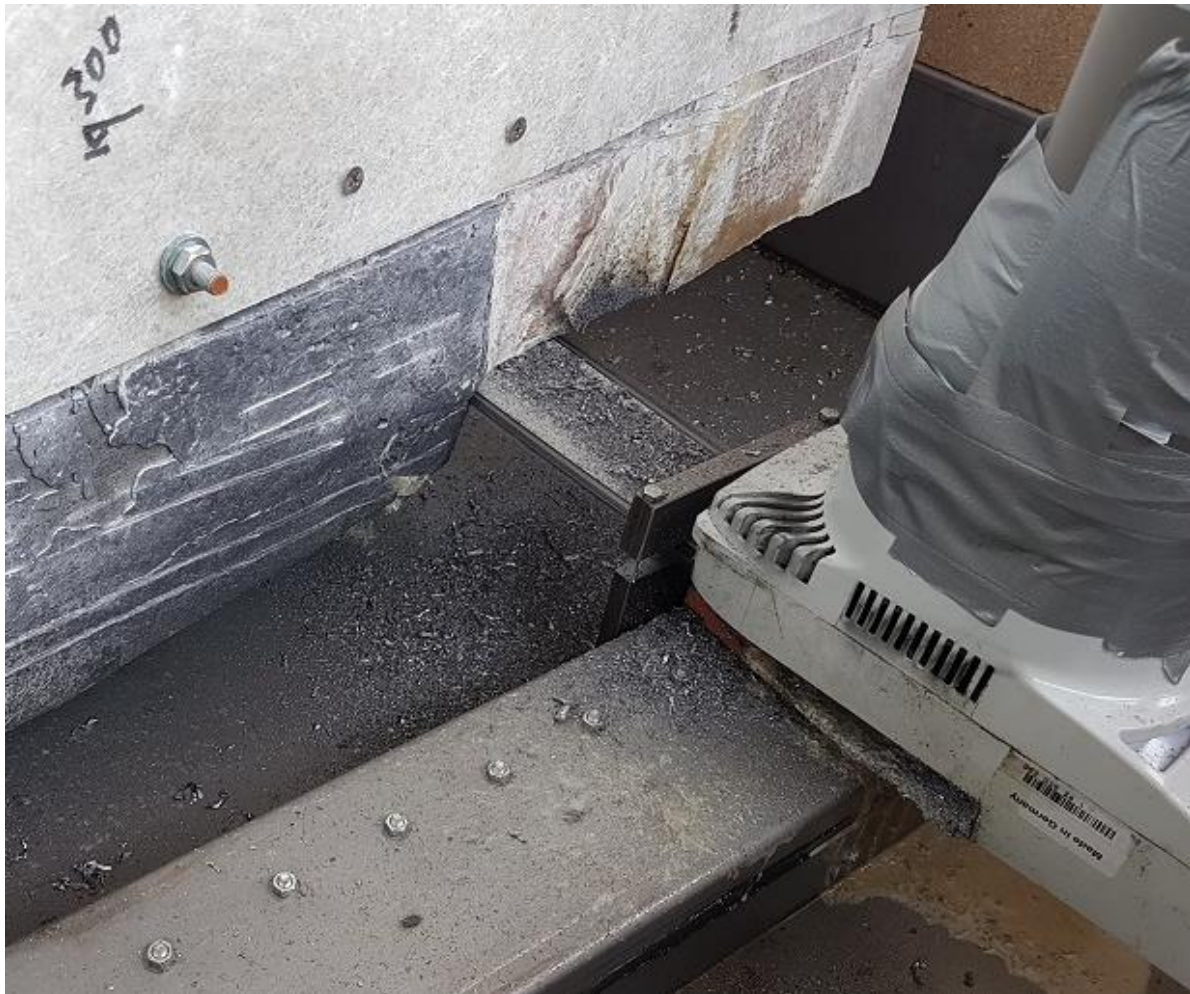
*Chainsaw at work.*

With these preparations complete, we levelled the saw and positioned the boat in the cutting box. Since the polyester had been removed, the saw only had to cut lead. After adjusting the blade pressure and speed via the drive spindles, we started cutting. The setup worked

extremely well, the entire operation was completed in just 6 working hours, which was faster than expected. The actual lead cutting took just 75 minutes. After weighing the sawn-off lead section (48 cm wide, 2.5 m long, 5 cm thick) and the sawdust, we determined that 300 kg had been removed.

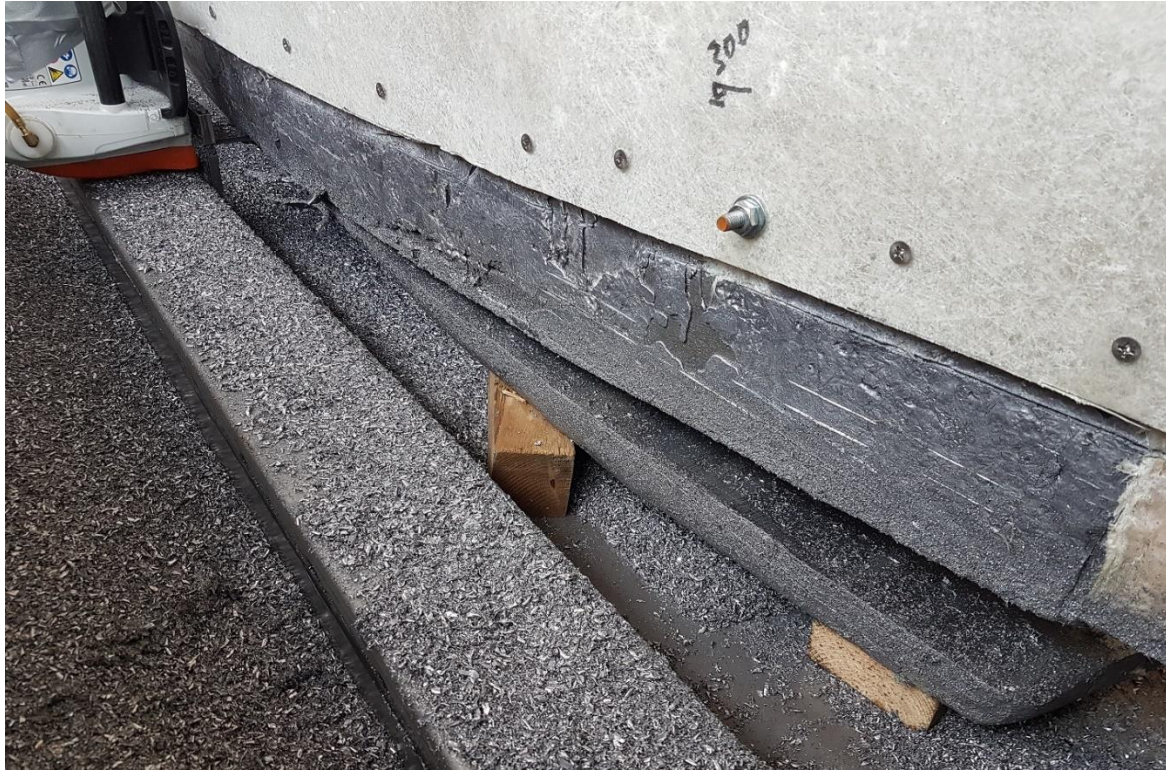
It turned out the lead keel was cast inside the hull and pre-filled with lead ingots to avoid excessive heat on the polyester during casting. The structure of the ingots was clearly visible in the sawn-off section.

*Chainsaw cutting through the keel and the removed lead section.*

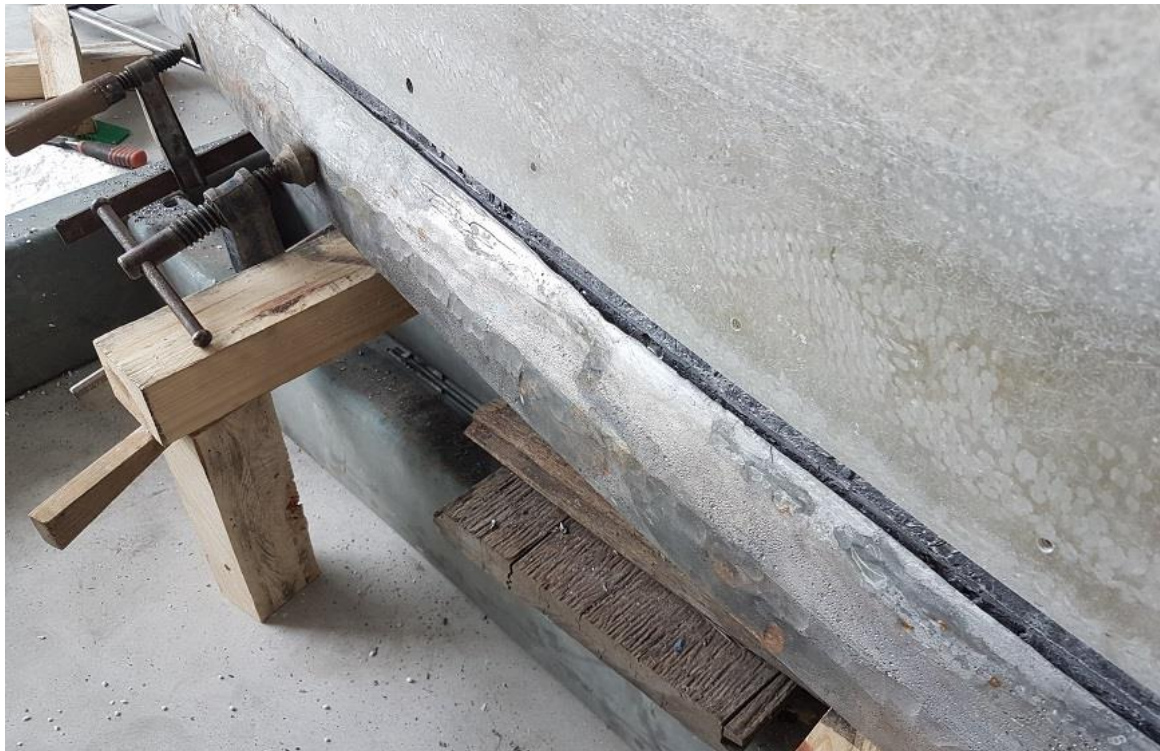
*Shaping and gluing the lead strips to both sides of the keel.*

Next, the cut lead was melted and cast into two moulds measuring 2.5 meters by 12 cm and 5 cm thick. This resulted in two strips weighing around 90 kg each. After shaping, the strips were glued to the sides of the exposed lead with an adhesive sealant (Adheseal), using clamps. Now only the fairing remained. The yard will handle the laminating and repainting of the underwater hull.

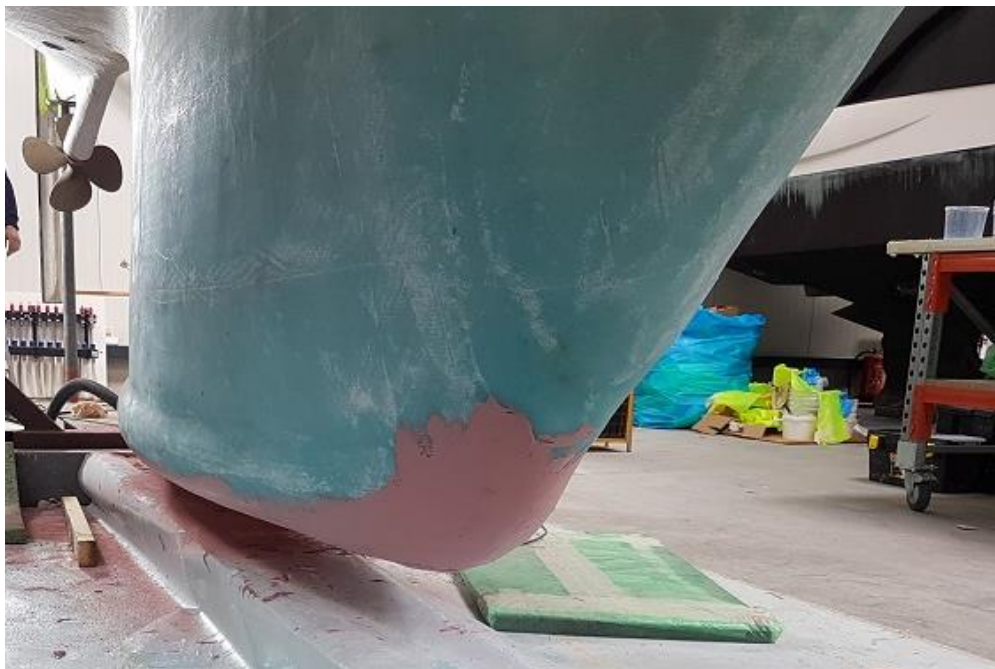
*Fairing and glass mat applied. The widened bottom section of the keel is clearly visible.*

After bonding the lead strips, we faired the joint with approximately 2 litres of epoxy filler to create a smooth transition. At the right curing moment, we used a sharp scraper to achieve the final shape - no sanding needed - ready for fiberglass matting. A total of 30 layers of mat were applied to the bottom and flanks in a stepped fashion.

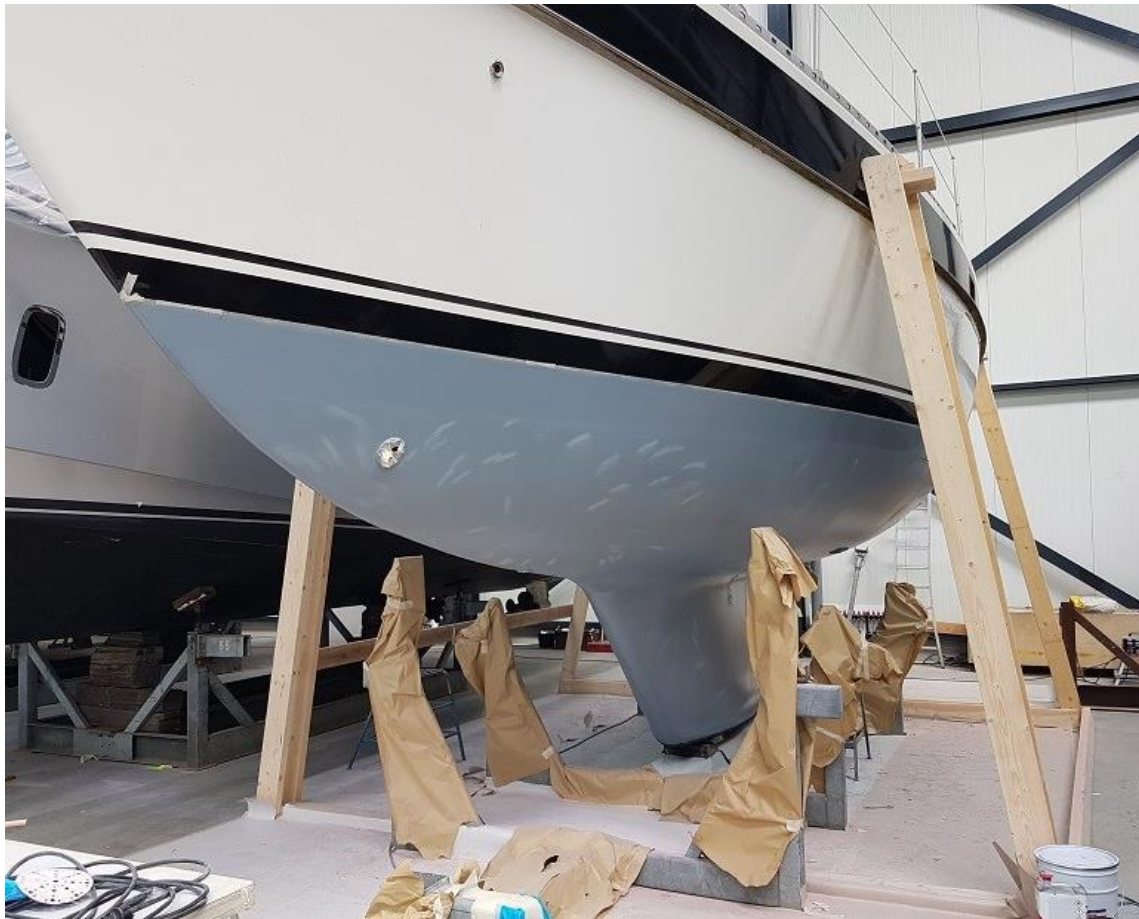
*Supported by beams through the windows, allowing full access for painting.*

To laminate under the keel, we supported the boat by the hull, lifting the keel off the ground. The underside of the keel was finished up to the antifouling layer. Once complete, we lowered the boat onto the keel in consultation with the yard. Support beams were placed through the portholes and secured with braces. This allowed us to remove the usual stands, giving us unobstructed access to the entire hull for epoxy and antifouling coating. The painters at the yard appreciated the unique setup, which made their work much easier. The rudder was also removed and fully serviced.
