Technical Information Bulletin No. 4/2025
Title	Restoration of sagging main bulkheads
Category	Construction Trintella 1 and 1a
Content	In the Trintella 1 and 1a models, the weight of the mast is transferred via the steel mast base and the underlying mast support to the two bulkheads in front of and behind the toilet area. In (early versions of) the Trintella 1 and possibly the earliest versions of the 1a, there is a risk of the centre section of these bulkheads sagging under the weight and forces exerted by the mast. This bulletin outlines the problem and demonstrates the solution.

Introduction

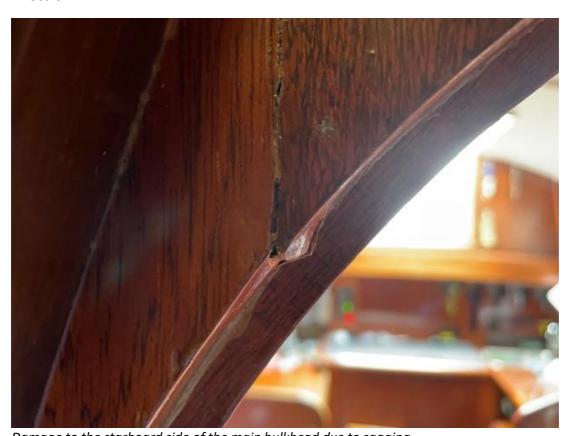
These bulkheads consist of three sections glued together vertically. This glue, dating from the early 1960s, ages and crystallizes, causing the bond to break. Because the mast foot rests on both bulkheads, heavy forces are exerted on the middle section of the bulkheads when the yacht pitches. This section sits above the doorway in both bulkheads. The impact forces the middle section downward. As a result, the doors can no longer open or close. In the Trintella 1a the doors do not close in a frame but close against the bulkhead. But a much bigger problem is that the mast is pushed downward, and the stays are no longer under tension. This poses a serious risk of losing the mast.

Damage to the starboard side of the main bulkhead due to sagging

First, check whether the middle section of your bulkhead has indeed sagged (see photo). If so, your cabin roof has also sagged somewhat. Using a beam and a hydraulic press, you can try to press the centre section of the bulkhead back into place (see photo by Cedric de Brauwere). The final solution must be sought in reinforcing both bulkheads on both sides so that the downward forces are properly directed to the outer edges of the bulkhead. The method of reinforcement is clearly visible in the photos. A horizontal beam with the correct curvature and sufficient height (strength against sagging) has been installed directly under the cabin roof above the doorway, and on either side, a beam that supports the horizontal beam and runs diagonally downwards, transferring the forces to the bulkhead sections on the sides. See also these links from Cedric de Brauwere with Trintella 1 Jadyca with BN 362, built in 1963.

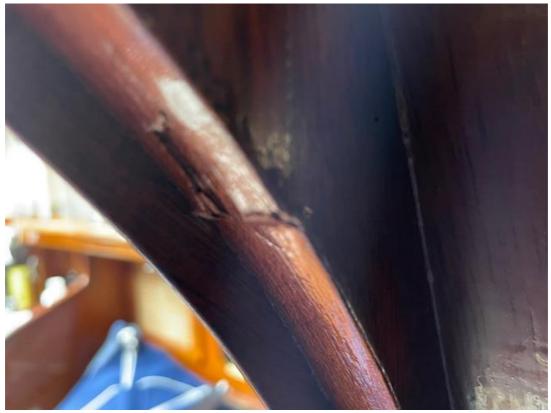
The cracked list on the port side of the main bulkhead

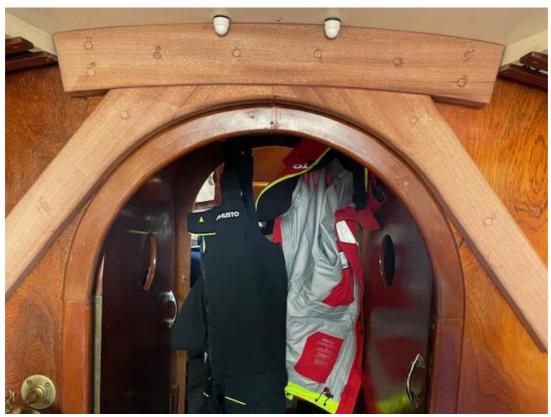
The reinforcement as seen inside the cabin. (Trintella 1-BN321-Castor Spica)

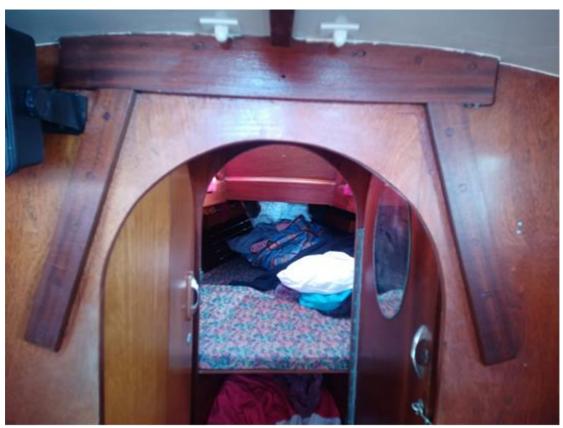
Trintella 1-BN 362-Jadyca-reinforcement bulkhead cabin-side

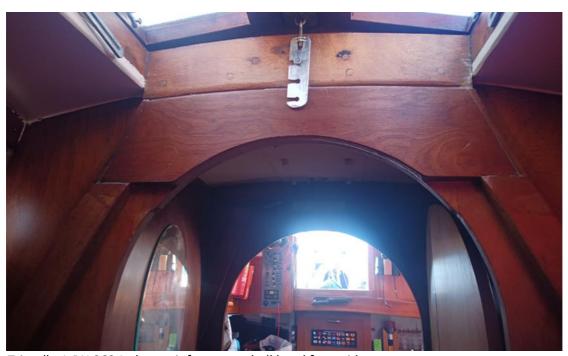
Trintella 1-BN 362 Jadyca-reinforcement bulkhead front side

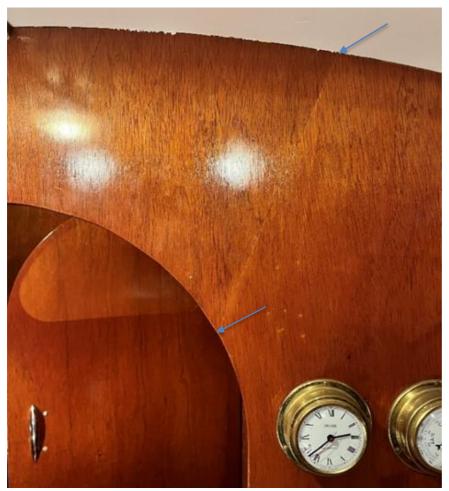
In later versions, this problem was resolved by gluing the three sections together in a trapezoidal shape and adding angled support beams, which distributes the forces more effectively and eliminates the risk of mast foot subsidence. However, there have been cases where the adhesive between these beams and the bulkhead has loosened. It is recommended to check the beam attachment for proper condition.

The trapezoidal shape of the center part with angled seam between the center part and side parts of the bulkhead as constructed in more recent versions of Trintella Ia.
