<h1 style="text-align: center;">Technical Information</h1> No. 06/1
Subject	Shroud chain plate – Maintenance checks and overhaul
Rubric	Rigging and Sails
Introduction	This information includes a ‘best practice’ of how to replace a broken shroud chain plate on a Trintella IV, Regular maintenance checks and attention paid to the state of the shroud and chain plates is essential to prevent dismasting and other unsafe situations.

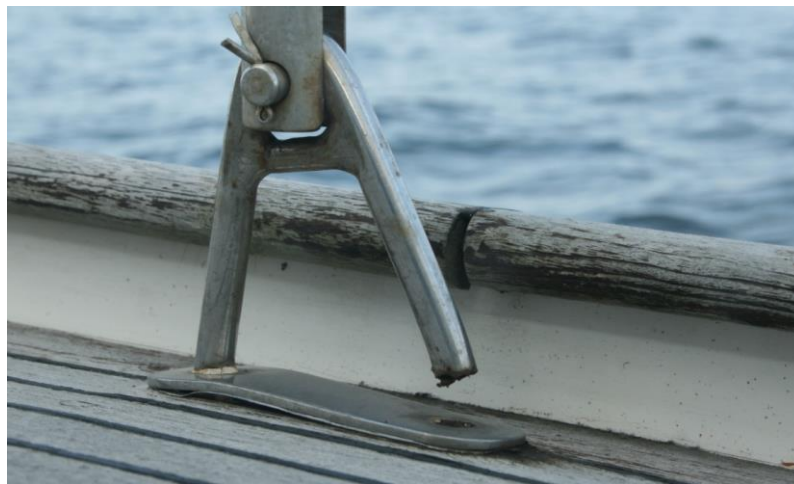
Once we were coming closer to our new mooring place, we stayed the night in a Marrekrite place to only have to sail another quarter of an hour to get to the harbor and take public transport home. We started the engine, made a plan to leave and the engine failed. We soon found the cause: water in the diesel pipe. From the tank to the jets, all filled with water. A few hours later, as I am washing my hands and look out into the side deck, I see a strange shroud chain plate:

Before, I put the broken shroud chain plate to one side and drew a quick conclusion that it was a bad weld. I did wonder why the part above deck was welded onto the screw thread below rather than being made up of one piece. I took the broken shroud chain plate back out and looked at it more closely to determine what was wrong. It appears that the cylinder gland studs below deck are made up of one piece with the part that is above deck. It is possible that the plate was welded to the brace on the deck to prevent leakage. On the bottom of the plate.

Apparently, we had been a bit too enthusiastic on the IJsselmeer, because this was not wrong when we bought the boat. I did not think about it much: just buy a new one, put it on, and done. However, you cannot just buy a new shroud chain plate. It was custom made in those days. So, after being creative with some stainless steel and having made a new one, remove the old one, put in the new one and done. That was all the attention I paid to it as I chalked it up to being ‘just something that can happen.’

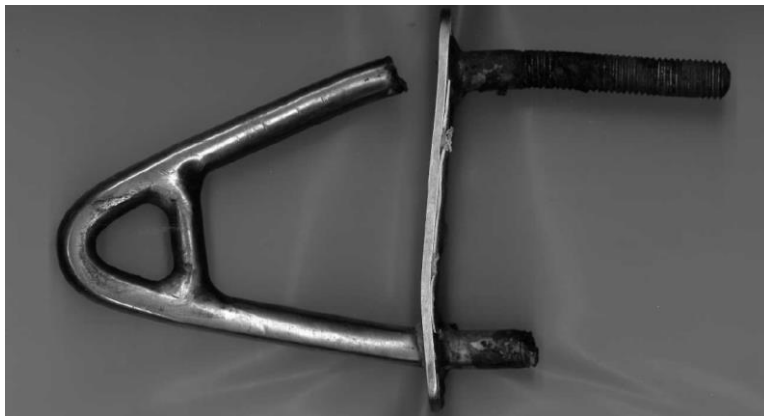
My further research is the reason I am writing this piece. Stainless steel from those days was not exactly of the same quality as it is now. Welding Stainless steel had to be prevented as much as possible, because the heating changes the structure of the Stainless steel which damages it quite severely. What remains is steel. As the next photo indicates in more detail:

Of course, I realized now that this problem is likely also there for the other 11 shroud chain plates... So I will be replacing all of them shortly to prevent any accidents from happening. With Stainless steel type -316/A4, as it should be. And without any welds, waterproofing is also perfectly doable with Sikaflex. Making one shroud chain plate was possible, making 11 is a bit much. It needs an expert eye to recognize these issues, so consider asking a professional for help. Or, do as I did and replace them all. You should not expect any support or understanding from your insurance...

I am going to draw a model in which the shroud can keep the same measurements so that does not have to be replaced. Even though Stainless steel 316 from 2017 can stand welding much better than Stainless steel from the 70s or 80s, I will stick with a brace and a Stainless steel plate above deck and a finish with Sikaflex below deck rather than welding. Including Stainless steel self-locking nuts.

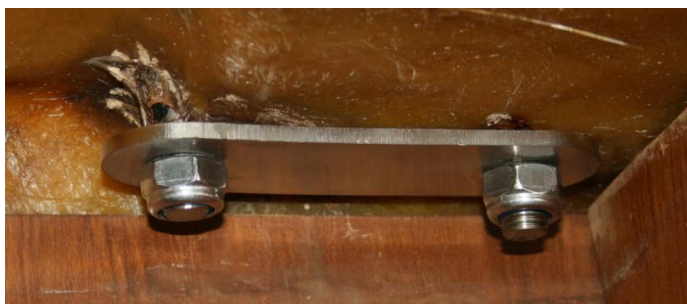
Due to a construction error a piece of screw thread was broken, we were very lucky that the stay hadn't come off the deck! The bolt was tightened too much and wrong positioning meant that the holes of the screw thread had already partly broken off. I have attached a mounting plate below deck as well:

This helps keep the screw thread ends in place.
