Technical Information

No. 09/1

Subject	Revising the Windscreen on Flush Deck Series and the 42
Section	Deck
Content	This information describes a 'best practice' for revising the fixed windscreen of a Trintella 38.

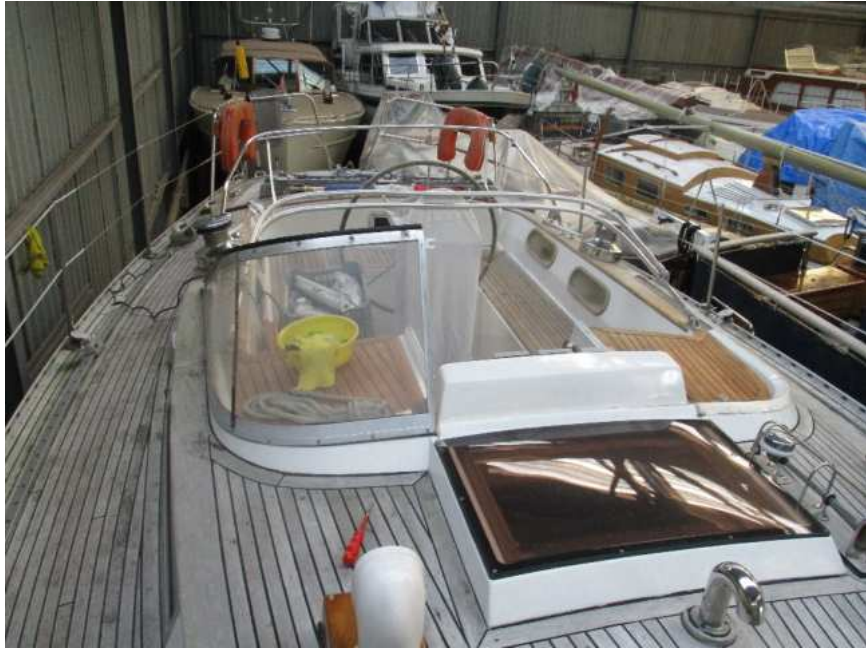
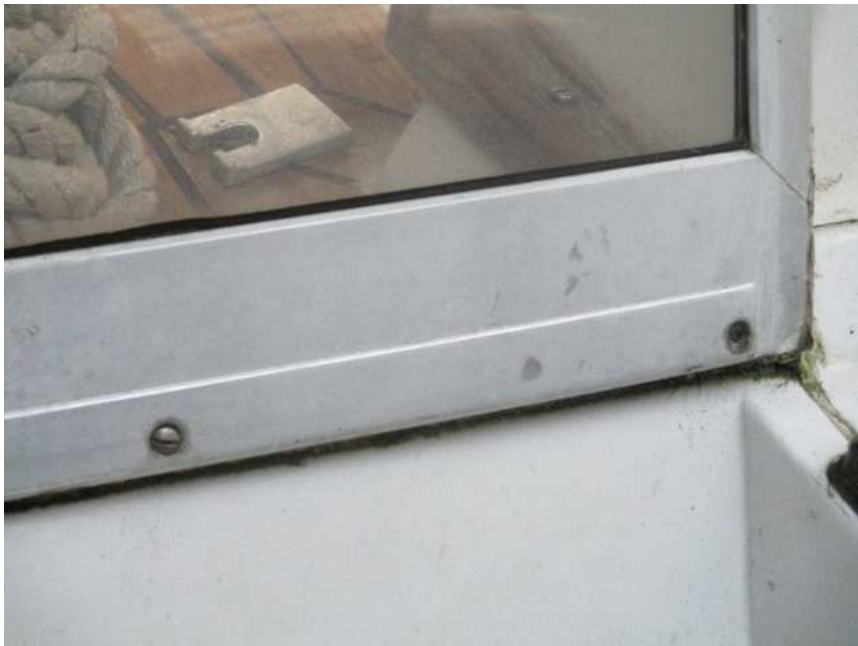
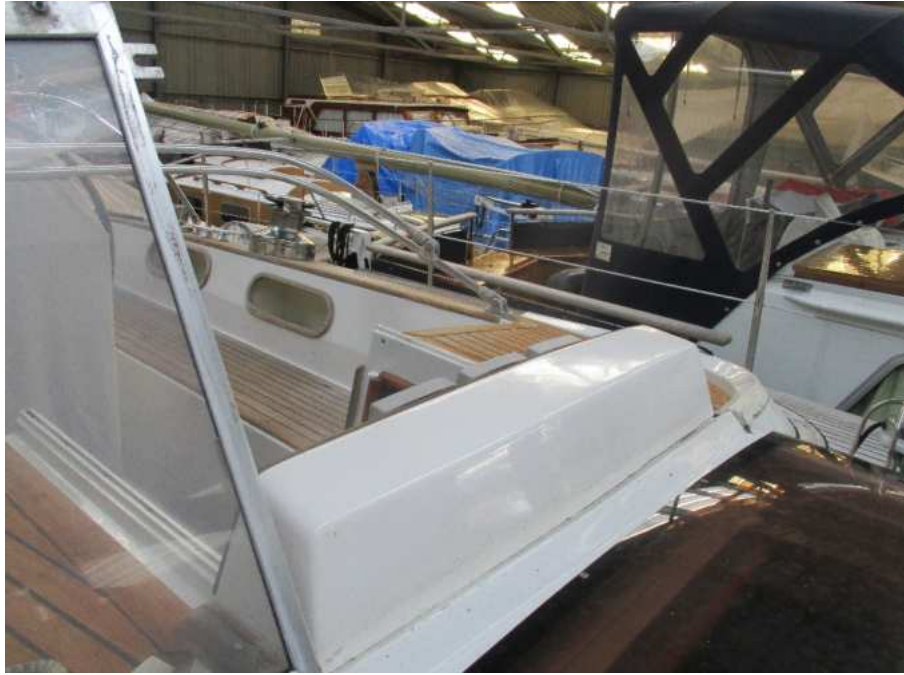
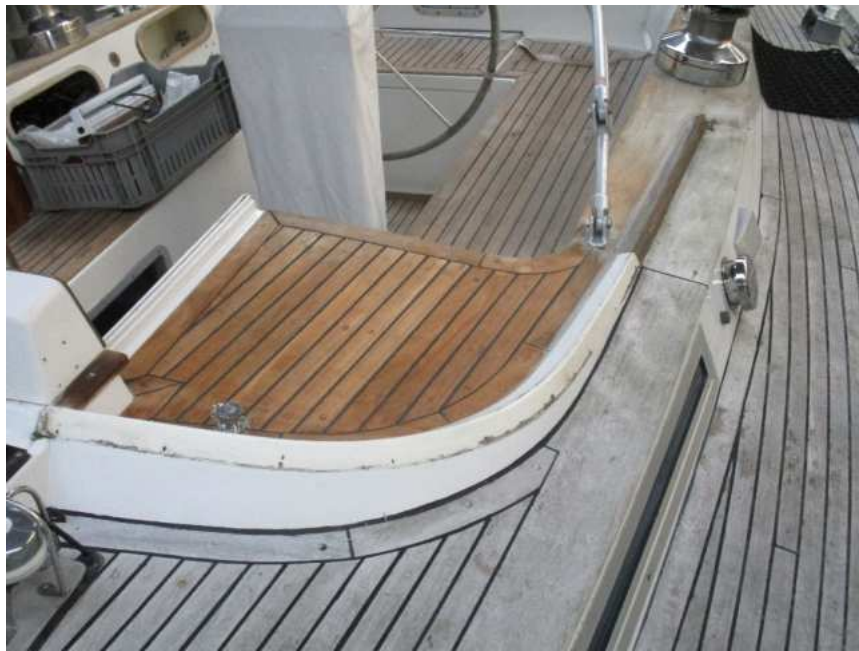
Under continuous exposure to sunlight and air pollution, the plastic materials used in the windscreen of the Trintella flush deck series (38, 44, 45, and 53) and the 42 can age and lose their functionality. Sealing rubbers become brittle and eventually cause leaks. The Perspex glazing develops cracks and loses its clarity. This document outlines the steps to perform a refit on a windscreen of a Trintella 38.

- **Remove the Center Panel:** After removing the cover from the spray hood, first, take out the center panel.
- **Dismantle the Side Panels:** Next, remove the two side panels by unscrewing the screws that attach the lower frame to the superstructure. The detached parts can then be taken to a suitable company. After comparing two quotes, I chose Rafa in Leiden, NL. Contact person: Mr. Erwin Septer.

- **Replace Rubber and Perspex:** The rubber is replaced with a sealed version, and the curved part is fitted with new Perspex. The entire assembly will then look sleek again.

- **Reinstallation:** Reinstallation can be done using the same window frames. However, if these are also in poor condition, the company can replace them as well.

- **Check and Repair Mounting Surface:** The lower edge (on the cabin superstructure) where the lower frame is mounted is partially wooden and partially polyester. For proper mounting, check if the screw holes need repair. In the wooden part, this can be done by inserting plugs to provide better screw grip. In the polyester part, you can laminate some wood on the inside to improve screw grip. Note that ceiling panels inside may need to be removed to access this area.

- **Seal the Lower Frame:** After installation, it is advisable to apply a bead of sealant to the lower edge of the lower window frame (curved part). This helps prevent capillary action from rain and spray water.
